Fish Mill Lodge
Coos County, Oregon

Water System
Feasibility Study

April 2009 Amended

April 2009 Amended
Project No. 2009.13

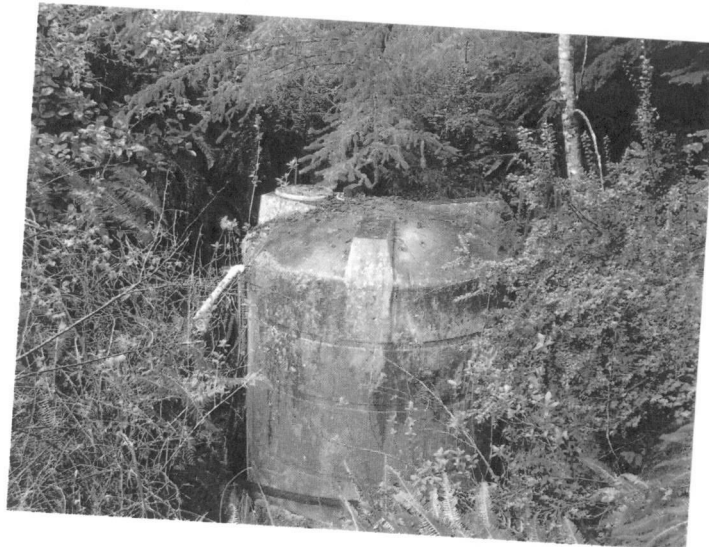
Figure 2-2-1 Existing Storage Tank

The storage tank is a 3,000 gallon clear plastic tank that is located on top of the old redwood tank floor. This redwood tank floor is acting as the foundation for the plastic storage tank and is deteriorating (see Figure 2-2-1). If the foundation fails under the strain of the storage tank, it may rupture the tank resulting in water loss for the resident and Fish Mill Lodge. A proper foundation should be designed for the storage tank in order to distribute the loading.

Sunlight penetrating the storage tank can enable algae growth. We recommend that the tank be painted or replaced with a NFS approved tank.

Fish Mill Lodge is located relatively close to the ocean putting the system in an area of heavy rain fall and corrosive salt spray. Based on the relatively small size of the system a 4,500 gallon water storage tank is recommended. This tank will need to be NSF approved and would benefit from being housed within the pump house building and out of the elements. A 4,500 gallon reservoir would give the system a 3 day supply of water based on the water usage provided by Fish Mill.

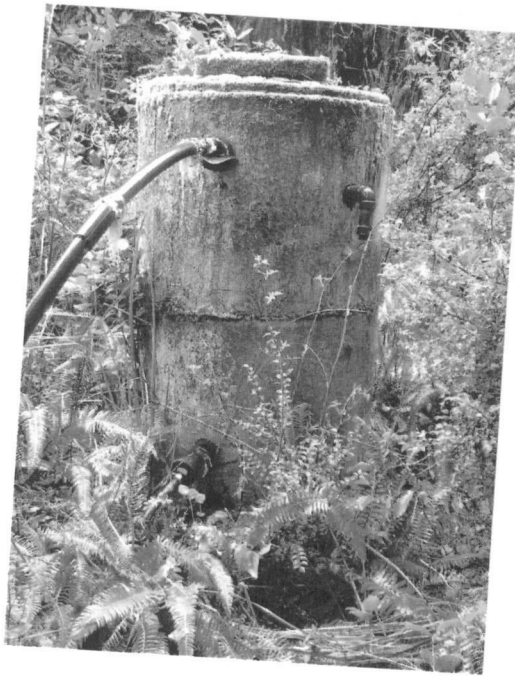
Figure 2-2-3 Existing Spring Box

The existing 42" spring box extends approximately 7 feet down into the spring head and extends 5 feet above the surface and is starting to show signs of deterioration and may be the source of the Coliform (see Figure 2-2-3). We recommend replacing the existing spring box with a new pre-cast 48" spring box with 3 feet of drain rock at the bottom. This could require a rail system for installation. The new pre-cast spring box would only need to extend 3 to 4 feet above the existing grade, and would have a small extended slab around the base.

The existing 42” spring box is in poor condition (see figure 2-2-3) and is recommend that it is replaced. A new 48” spring box will allow for more water storage during the dry periods and should incorporate a poured in place slab around the structure to help support it. The spring box would extend approximately 7’ down into the spring and have a 2-3 foot drain rock base below the structure (See Table 3.2).

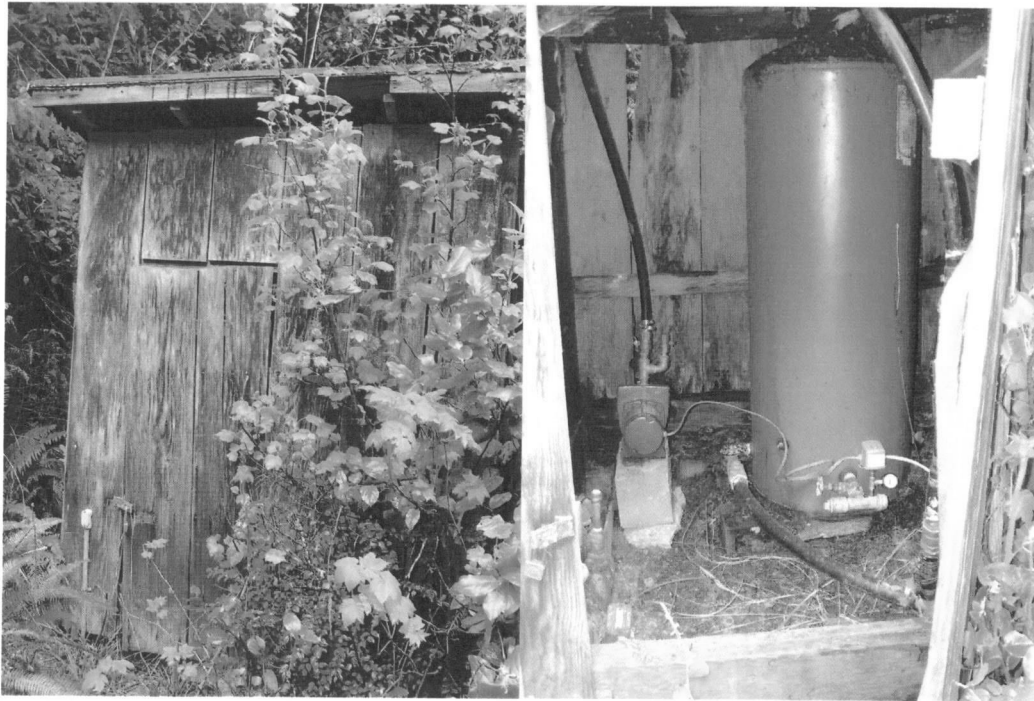
Figure 2-2-4 Existing Pump House

The existing pump house building is in poor condition (see Figure 2-2-4) is rapidly deteriorating, and does not have the room to house a sodium hypo chloride chlorination system with the pressure tanks and pump(s) configuration. This new building could be a stick-built structure with a concrete slab on which the pumps and pressure tank can be mounted.

feeds the distribution system (see figure 2-2-4). The pressure throughout the distribution system ranges between 32 psi at the highest elevation service and 38 psi at the lowest service. Pressure setting on the pressure tank should be higher, which could indicate that the tank may have a air leak or some other problems with the bladder.

The existing pump house building that houses the water storage tank pump along with the pressure tank is in poor condition and is recommended that it be replaced. A new structure could house the new pumps, pressure tank and tablet chlorination system. This structure could also house the storage tank protecting it from the elements and vandalism. The new building could be fenced in with a 6 feet chain link fence with security wire (razor wire) on top to reduce the problems Fish Mill is experiencing with vandalism (see Table 3.4).

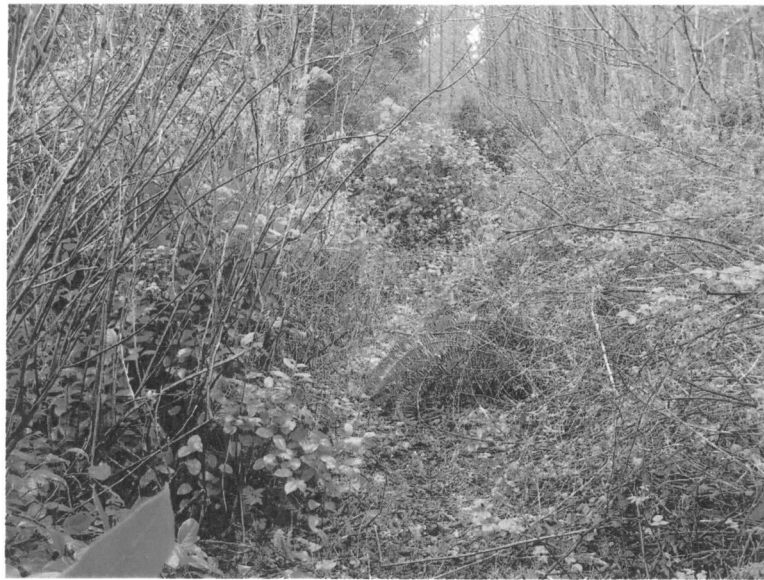
Figure 3.9 Access Road

Fish Mill Lodge water system is breaking down and in need of repair and replacement of some of the system components. The location of the pump house and storage tank does pose an access issue. Both are located approximately 700 feet up a foot path with no vehicle access (see Figure 3.8). Also, there has been a security issue with the existing pump house. A possible solution would be to relocate the pump house near the lodge itself. This would allow for more security and ease of maintenance. The new pump system is more than capable of maintaining adequate pressure throughout the distribution network. This option would require some additional water line installation, but would not require a new road to access the existing pump house location.
