Re: In the Matter of PORTLAND GENERAL ELECTRIC COMPANY
Application to Amortize the Boardman Deferral.
Docket No. UE 196

RESPONSE TESTIMONY OF

JOHN R. MARTIN, P.E.

THE INDUSTRIAL CUSTOMERS OF NORTHWEST UTILITIES

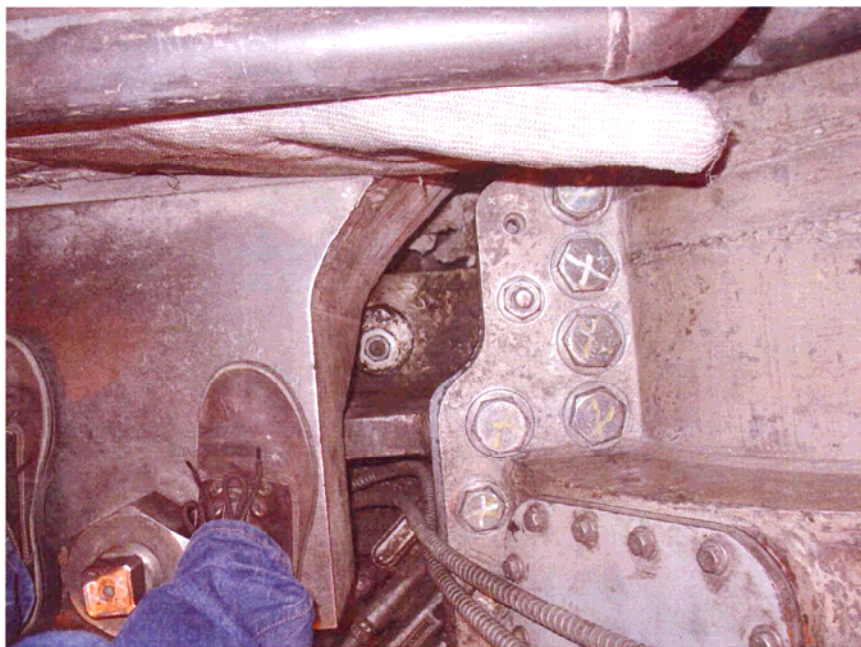
1 true at the time of my visit. The two nuts that were reported to be missing are
2 somewhat difficult to see when the turbine is assembled, but they are visible.

3 ICNU/404, Martin/1 is a photograph of Nut No. 25 that was reported
4 missing by PGE. ICNU/405 Martin/1 shows the photograph taken by the PGE
5 technician in June 2006 of the same nut. Clearly, the PGE technician who
6 observed the missing nuts in June 2006 was able to also see that they were
7 missing without disassembling the turbine. ICNU/406, Martin/1 is a photograph
8 of Nut No. 2 that was reported loose by PGE. ICNU/407, Martin/1 shows the
9 photograph taken by the PGE technician in June 2006 of the same nut.

Sole plate under bearing #2, bolt #25.

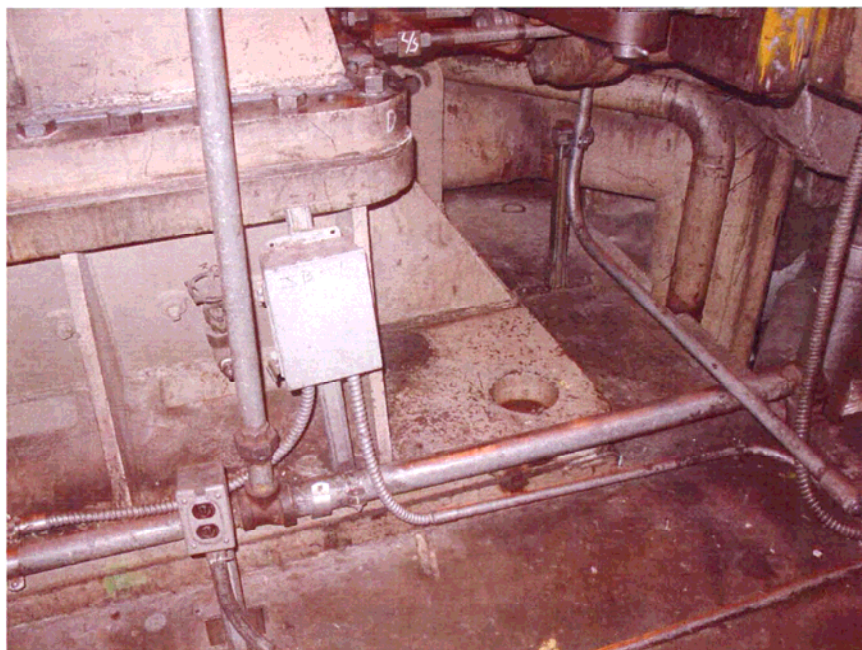
South West corner of LP-1, bolt # 2.
