From: E W [REDACTED]
To: [REDACTED]
Subject: UM 2280, Sun Country Water in Saddleback
Date: Saturday, June 10, 2023 9:17:20 AM

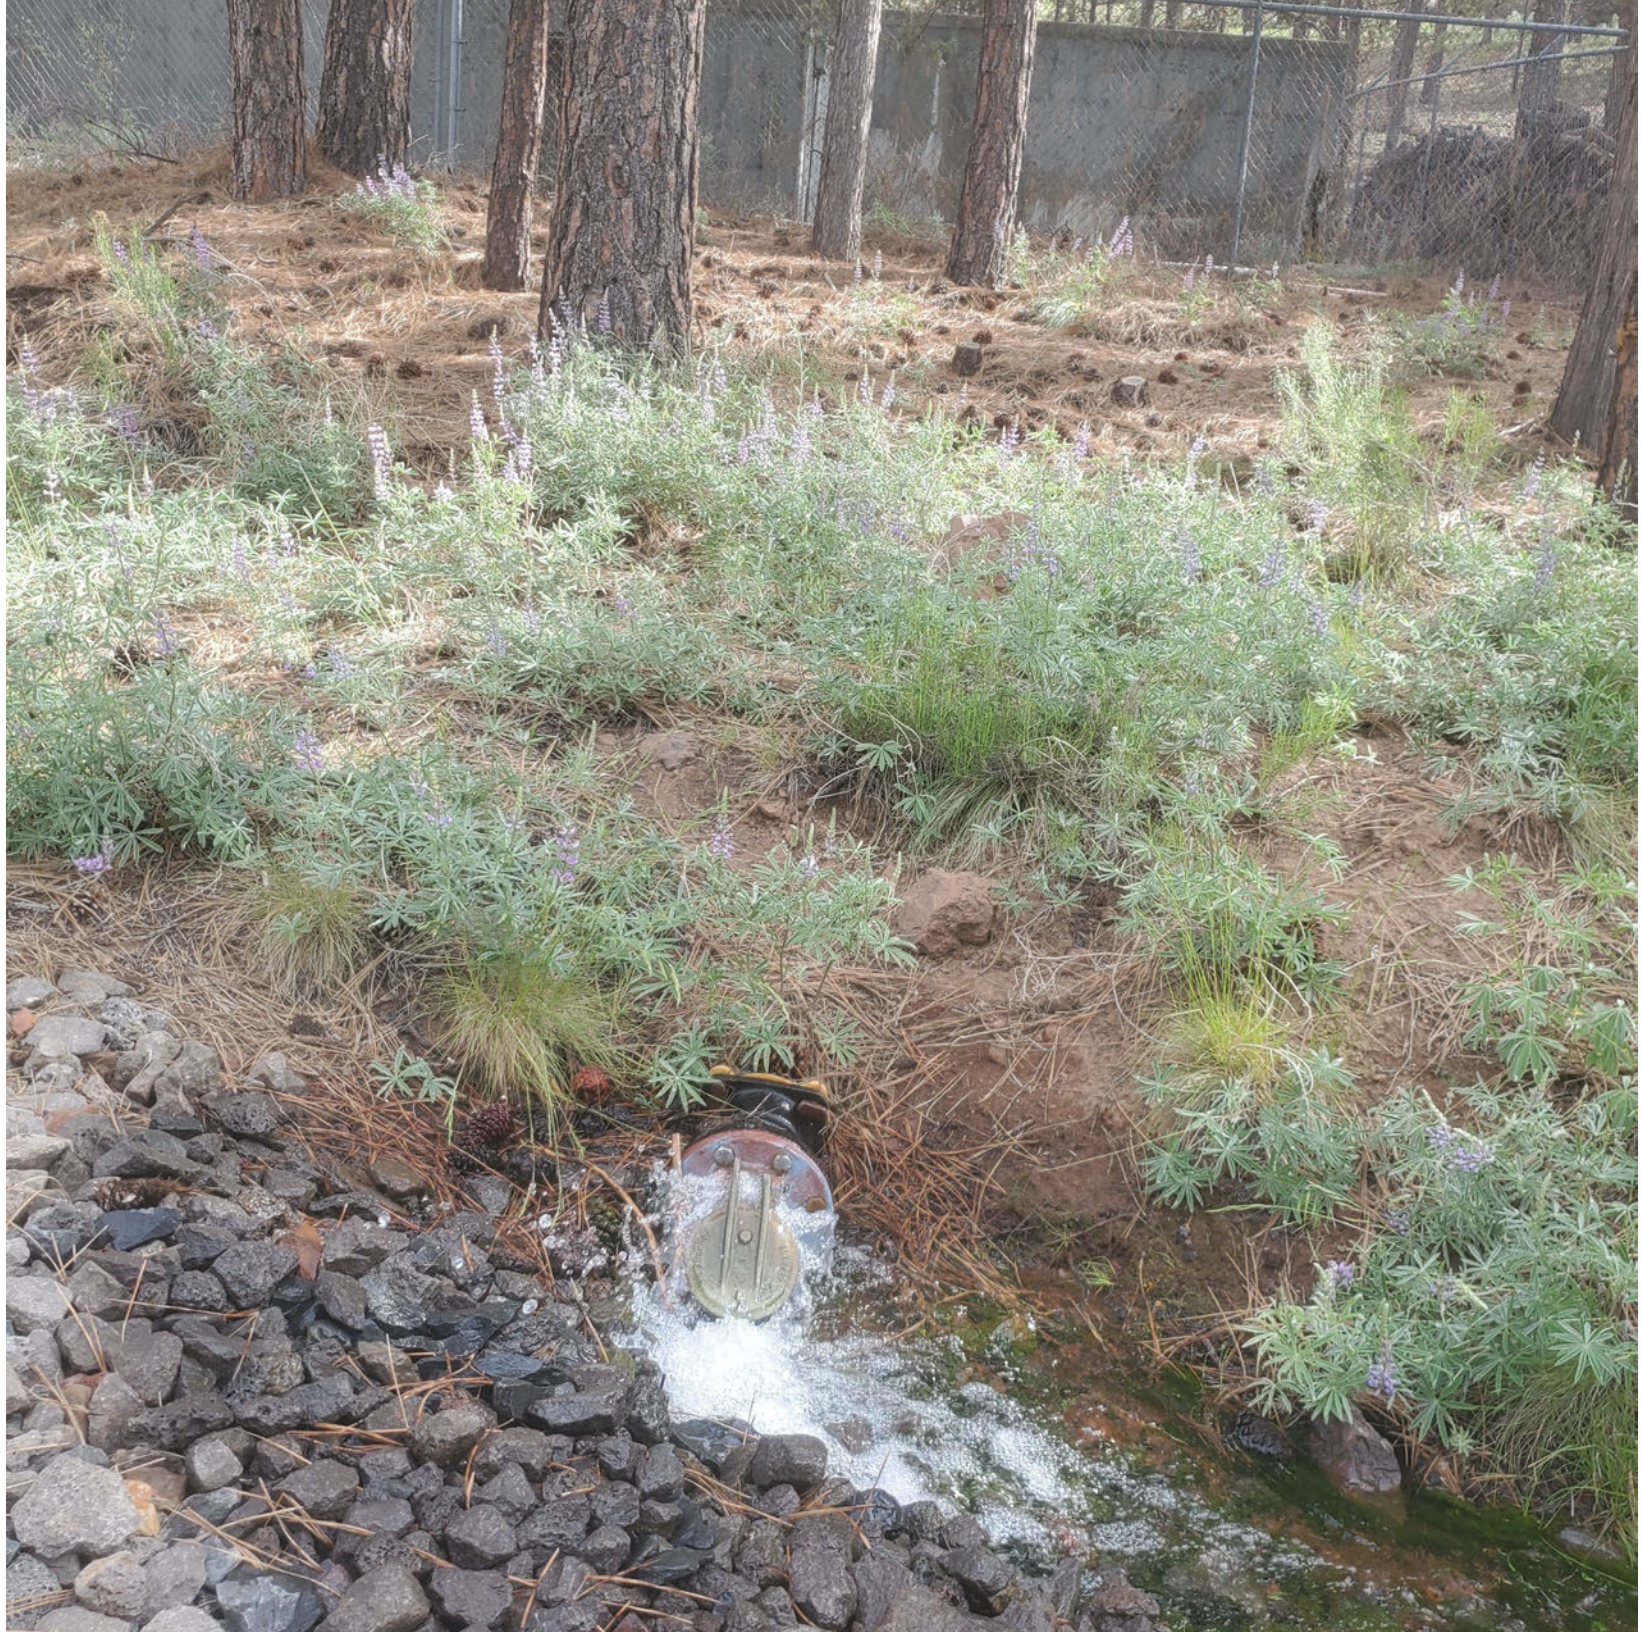
The attached photo was taken at 4:28 PM on June 9, 2023. It shows water overflowing from the SCW reservoir (fenced structure in the background) on Saddleback Lane. The approximate coordinates of the outlet pipe are: 44.0979, -121.3692.

These overflow events occur frequently. There is clear evidence of erosion in the street ditch downstream from the outlet, but not upstream. Green grass and moss or algae shown in the photo are evident in the ditch below the outlet, but are not present above the outlet.

I've heard that the original design and implementation of the system included automated controls to keep the reservoir full while not creating overflow situations. Based upon the continued reported water outages in that part of the neighborhood and the common observances of overflow events, the automated system does not appear to have been functioning properly for at least the last several years.

I hope the PUC can help remedy this and other operational issues which SCW is experiencing.
