April 17, 2007

RE: **Docket No. UM-1308**
PacifiCorp *Revised* Proposal for Implementing Division 24 Pilot
Program Phase-One

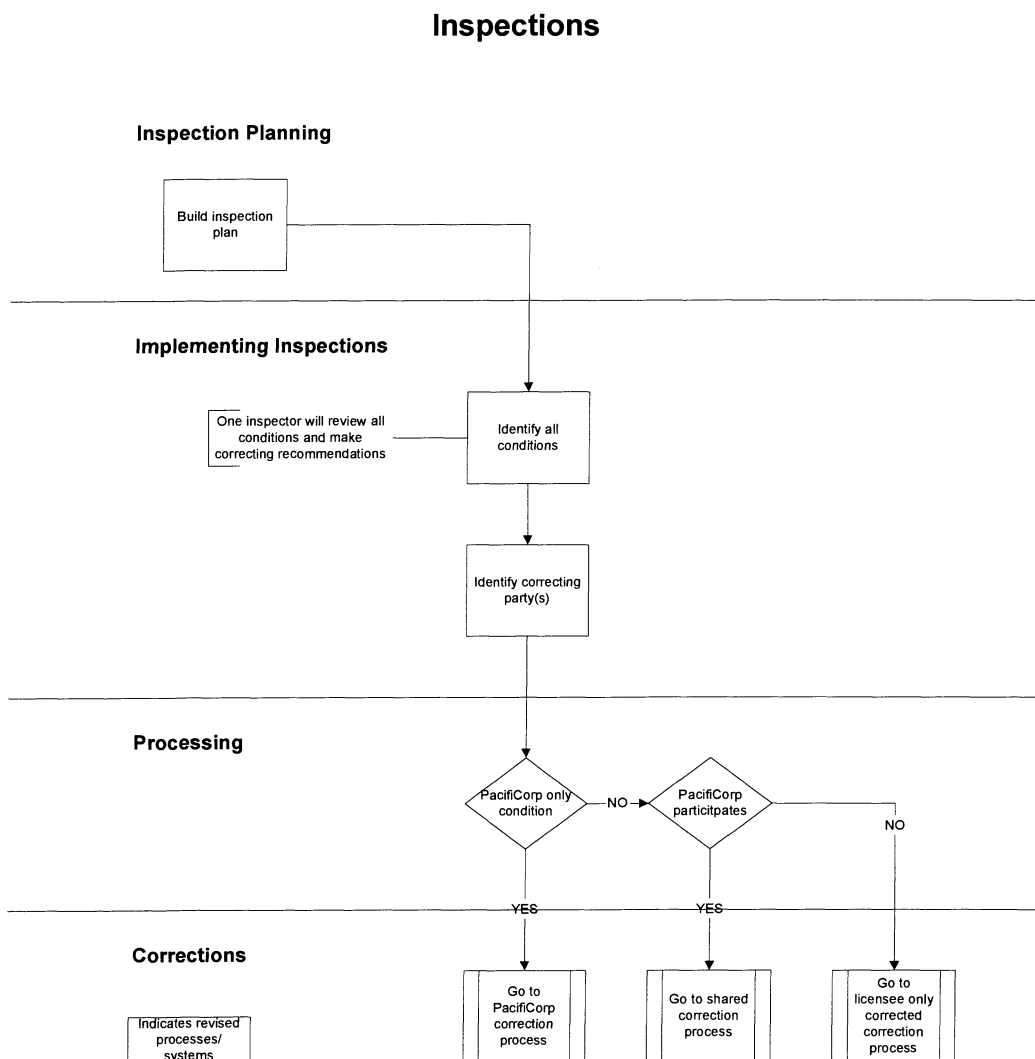
Additionally, in order to leverage inspections performed at company poles, additional detail will be captured to support correction plans being developed early in the process. The inspector will identify the most likely party to correct each condition, fundamentally identifying whether that correction is the company's responsibility or that of a joint pole user.

The diagram below outlines the current inspection process and includes the additional step identifying the correcting party in "yellow" (shaded).
