**BEFORE THE PUBLIC UTILITY COMMISSION**

**AR 506**

In the Matter of a Rulemaking to Amend and Adopt Permanent Rules in OAR 860, Divisions 024 and 028, Regarding Pole Attachment Use and Safety

**FIRST ROUND COMMENTS OF  
PORTLAND GENERAL ELECTRIC  
COMPANY**

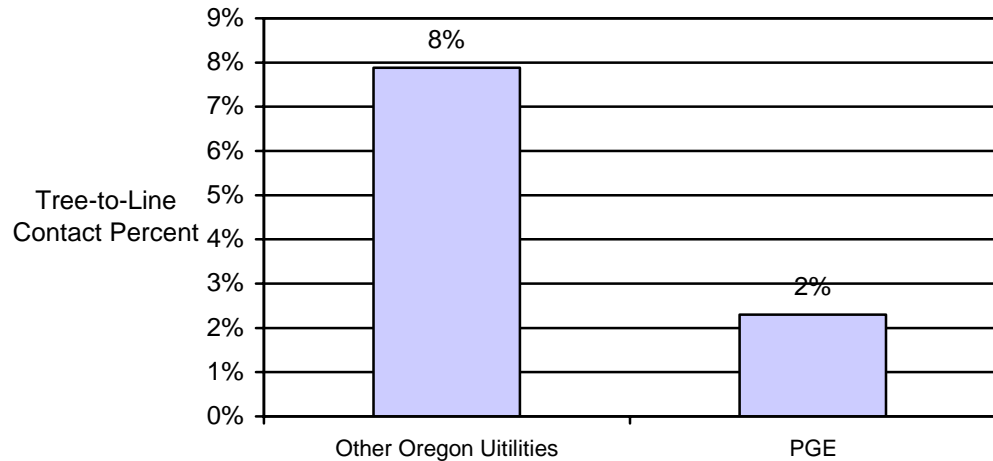
**Figure 1. Tree Contact (Less Than One Foot of Clearance) with Primary Conductors at PGE Is Well Below that Observed Across the Territories of Five Other Oregon Utilities in 2005.**

Figure 1 compares PGE's tree-to-conductor contact with that of five other Oregon utilities within the Willamette Valley, including rural electric cooperative, investor-owned and municipal utilities. As shown, average tree-to-conductor contact at PGE was found to be 75 percent lower than what was found at the other utilities. Both of these percentages of trees in contact with the conductors are also well below what ECI has observed as the industry norm.

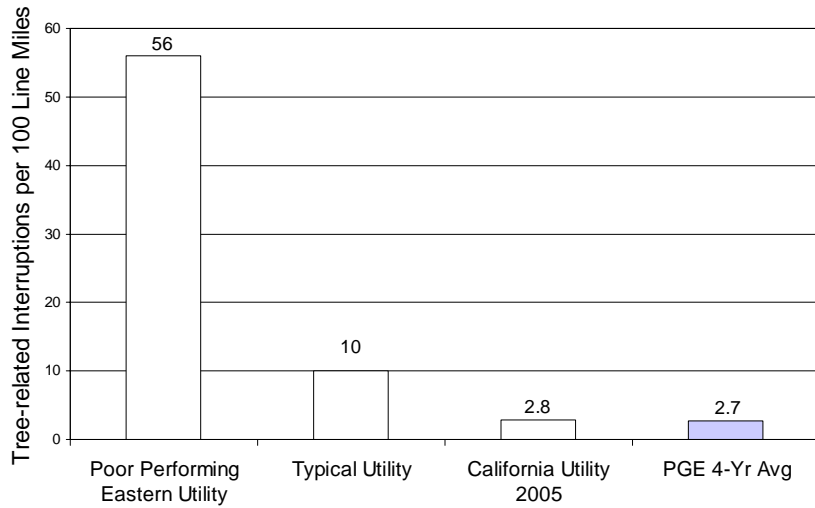
**Figure 2. PGE’s Performance In Terms of the Annual Number of Primary Tree-Related Interruptions per 100 Miles Is Quite Good as Compared to Representative U.S. Utilities.**

The very low level of tree-to-conductor contact would suggest that PGE should be experiencing relatively low numbers of tree-caused service interruptions and this is the case. In fact, the number of tree-caused interruptions on the PGE overhead primary system per 100 miles of line was found to be among the lowest of any utility in the United States that ECI has examined. The frequency of tree-caused service interruptions at PGE was at least 30 percent, and as much as 80 percent lower than several benchmark groups of U.S. utilities. Figure 2 compares PGE's average number of tree-related interruptions per 100 miles of line with several representative groups from throughout the country.

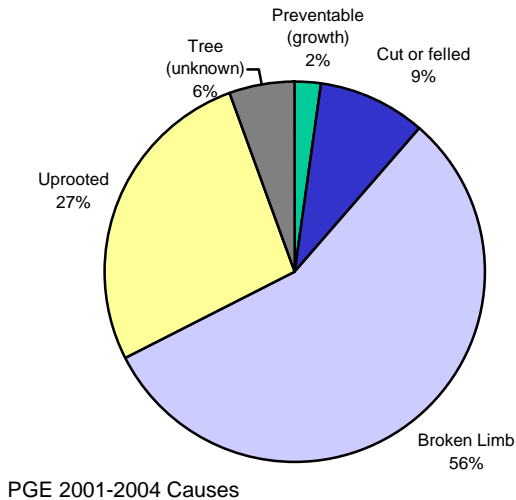
**Figure 3. Service Interruptions Caused by Tree Growth, the Primary Target of Routine Tree Maintenance, Is Quite Low at PGE as Compared to Other Electric Utilities**

Of the tree-caused interruptions that do occur on the PGE system, few have been the result of trees growing into the conductor. The vast majority of interruptions have been attributed to unforeseen or non-preventable tree failure, including broken limbs, uprooted, cut or felled trees (Figure 3). ECI’s experience shows that most utilities experience a much higher proportion of outages due to tree growth than has PGE. This finding is consistent with the relatively low tree-to-conductor contact observed and discussed above.

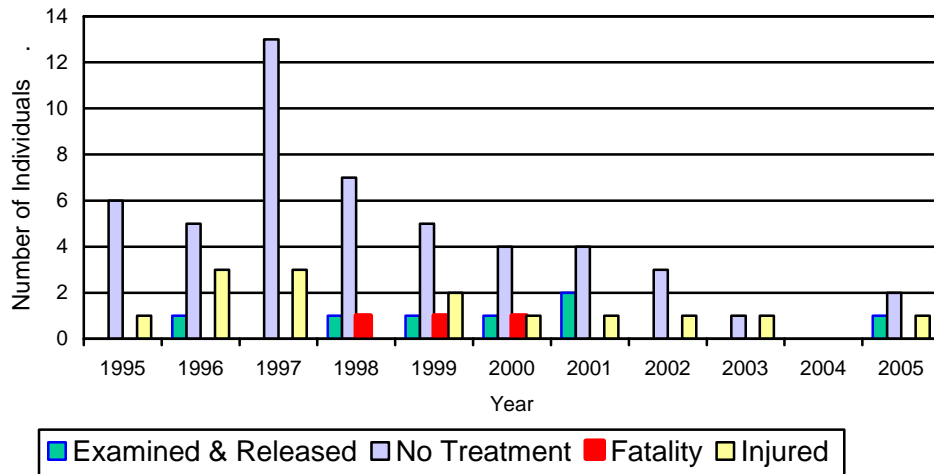
**Figure 4. Total Statewide Tree-related Contacts with Power Lines by People<sup>1</sup>**

Oregon utilities and the OPUC document all known incidents involving public contact with energized conductors in association with trees. ECI categorized each tree-related contact reported based on published descriptions as either examined and released, no treatment (treatment refused), injured (non-fatally), or fatality (Figure 4).

ECI's examination of OPUC incident reports indicated that a total of 74 individuals were reported to have experienced a tree-related contact with overhead conductors. Categorization of incidents by year may be slightly different than listed in OPUC reports due to differences in year of occurrence and year reported. OPUC records report that statewide, there have been an average of five public tree-related contacts with power lines reported per year over the past 20 years. Statewide, these incidents have been declining over the past five years and there were zero incidents in 2004. Many of these incidents are related to adults attempting to trim or remove trees in the vicinity of power lines. Few incidents resulted in injury that required medical examination or treatment. Over 75 percent of the persons reported declined hospital treatment or were examined and released without any reported injury.

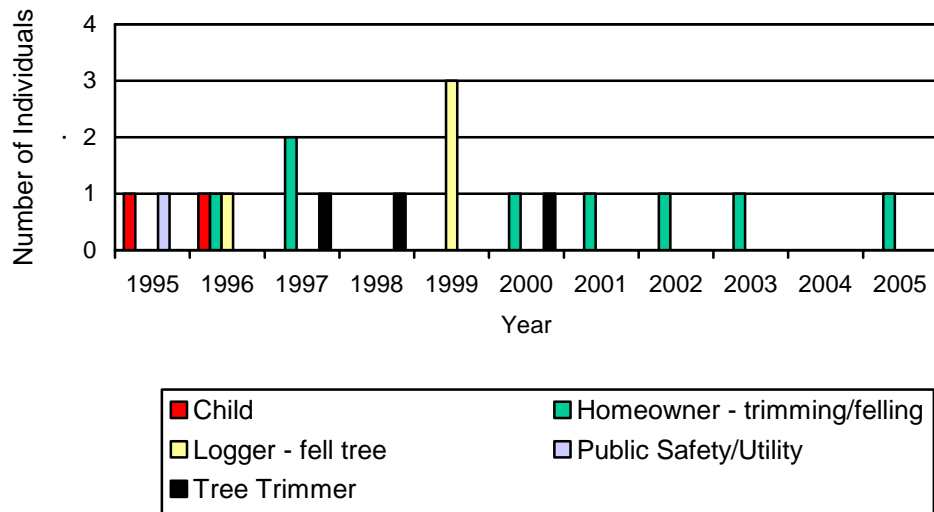
**Figure 5. Total Statewide Tree-related Injuries and/or Fatalities**

ECI categorized the individuals that were described in the reports of tree-related contacts as children, homeowners, tree trimmers (working for a company or self employed, loggers, or public safety/utility employees (including cable television, utility linemen, and firemen). Contact incident descriptions regarding individuals who were either injured or killed (examined and released and treatment refused excluded) are summarized in Figure 5.

It is important to note that review of the incidents in Figure 5 above shows that the proposed OPUC rule changes would have minimal if any affect on the number of injuries or fatalities experienced throughout Oregon. Based on ECI's observation of industry practice, utilities address such risk through public education, warning signs and responsiveness to customer requests for assistance in partial clearing of trees away from power lines to facilitate safe tree maintenance by the customer or their arborist. Utility companies cannot prevent people from ignoring warnings and obvious hazards or becoming involved in inherently unsafe acts. OSHA regulations and American National Standards Institute (ANSI) standards address electrical contact hazard by requiring non-certified line clearance tree workers to stay at least 10 feet away from any energized conductors. However, even these national standards and federal regulations do not
