BEFORE THE PUBLIC UTILITY COMMISSION

IN THE MATTER OF IDAHO POWER COMPANY'S, PETITION FOR	Docket: PCN 5
CERTIFICATE OF PUBLIC CONVENIENCE	Intervenor Cross-answering and
AND NECESSITY.	Rebuttal Testimony
	Sam Myers

Date: March 20, 2023

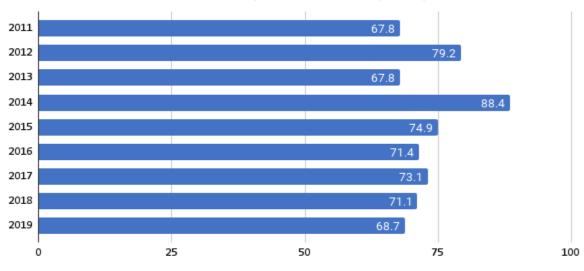
Max Wind Speed Each Year

I appreciate Mr. Stipple's testimony concerning transmission line tower design. He uses various data from ASCE that references local charts for Umatilla and Morrow County to make this critical determination of 85 mph basic wind speed which is used to specify wind pressures and max wind speeds. This determination is the starting point on which the towers are designed from. The chosen 85 mph distinction carries an MRI distinction of 100 years based on ASCE charts that Mr. Stipple provides. This means that wind speed at 85 mph should only be seen once in 100 years which would be a 7.7% chance of a 85 mph wind event happening in the next 8 years. In my amended testimony, we source wind data from a commercial wind metering tower that was placed on Carpenter Butte (0.6 miles from proposed transmission line) in 2011 and taken down in 2019. This wind metering tower recognized speeds of 88.4 mph at 164' high and is recorded at several other elevations on the tower on December 11th, 2014. As seen in the graph below we had two wind events: the first was in 2012 at 80 mph and the second was in 2014 at 88 mph. The probability of a 50 year event and a 100 year event taking place within two years of each other suggests that the basic wind speed is underrated and we are eclipsing the ASCE's derived basic wind speed. In other words, the winds at this location are much stronger and more frequent than the 85 mph/100 year MRI classification that is specified. The applicant has repeatedly stated they "have met the most stringent standards"; however, it appears that those standards have been intentionally lowered in this case. I contend that this initial determination of 85 mph is not an adequate number for our location as a design wind speed.

Max Wind Speed Per Year (MPH)

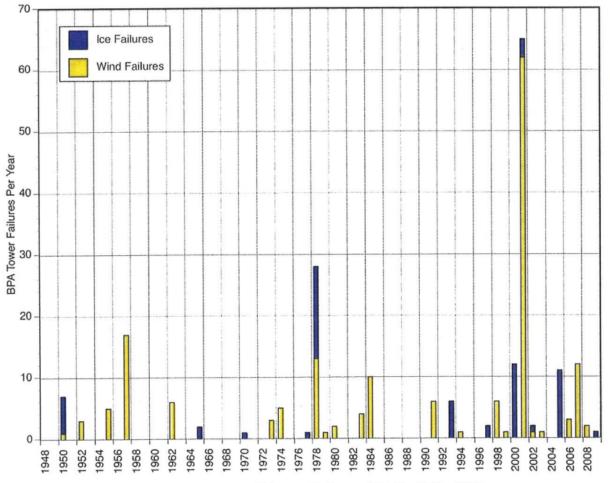
Figure 3-1 Reported Tower Failures (BPA), 1948 - 2009

In literature from BPA we see that there is a failure rate among 115 kV and 500 kV towers as demonstrated in Figure 3-1 (below).

The data in Figure 3-1 is thought to be nearly complete for steel lattice structures. The data in Figure 3-1 may omit data for damaged wood pole-type structures if the construction crews effected repairs without specifically reporting said repairs to the BPA transmission group. Most of the damage in Figure 3-1 was for towers on 115 kV to 500 kV lines, and could be due to wind- or ice-plus-wind-induced overloads on specific above ground members or foundation failures; in a few cases, the damage was caused by wind-induced fallen trees. Damage due to landslides, snowslides, vehicle impact, airplane impacts or other non-weather related causes is not included in Figure 3-1.

optimization and reliability of the grid whose tower resiliency is at the top of the list. This juxtaposes the statements made in Idaho Power's reply, that there are very rare failures. Figure 3-1 appears to indicate that tower reliability is not as assured as we would be made to believe.

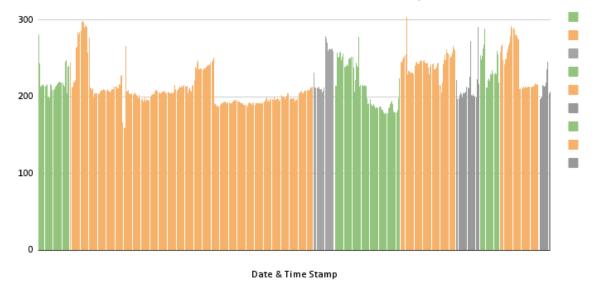
An ASCE study on Fragility Analysis suggests premature tower failures can occur from specific wind attack angles and incorrect max wind speed ratings on transmission towers. ASCE has recently started the use of fragility tests to determine performance-based design guidelines for transmission lines in high wind regions that include structural and reliability factors. In this study they conclude that this particular design tool may be new in the industry but does provide guidance in determining wind effects on transmission line towers when specific wind attack angles are applied. They find that a wind attack angle of 67.5° presents a dramatic increase in fragility to the tower and a collapse can happen at much lower winds speeds than the original tower maximum wind speeds design. The graph below is the weather direction data sourced from a commercial wind tower on Carpenter Butte, 0.6 miles from the proposed B2H transmission line that was in operation from 2011-2019. The change of colors indicate the year change starting from 2011.

Legend - North = 0° - East = 90° - South = 180° - West = 270°

tower more susceptible to wind failures. This chart shows the sheer number of 60+ mph occurrences that is consistent with commercial wind areas. We seek to show the frequency of wind events that a potential transmission line would need to resist. Our location will have a large number of high winds within the attack angle range. Our concern is that the current tower and line types wouldn't withstand the attack angle stress on a continual basis.

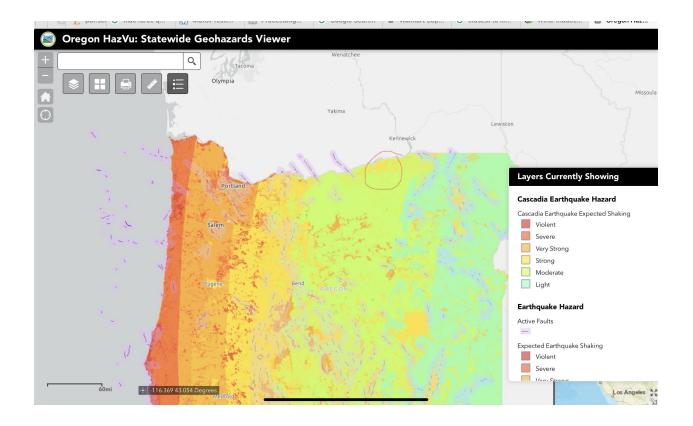
IPC, in their final order September 7, 2022 (page 121), quotes a standard from the ASCE "guidelines for electrical transmission line structural loading", it reads as follows: "transmission structures need not be designed for grounded use vibration caused by earthquake motion, because historically transmission structures have performed well under earthquake events and transmission structure loading is caused by wind ice combinations of broken wire, horses, exceed earthquake loads". IPC claims to have prepared for extreme environmental events but has added no additional loading in preparation for a Cascadia earthquake. The Cascadia Seismic event is characterized as imminent and will have a dramatic impact across the entire state. This event is forecasted to produce a magnitude 9.0 or higher earthquake. IPC has described that there may be some overlapping of loadings between ice, wind, etc.; however, we are due for a catastrophic earthquake in Oregon which actually elevates the seismic hazards in all locations of Oregon. There is no history in our settlement of Oregon that can tell us how the Cascadia event will impact transmission lines. We simply must be prepared and have done our due diligence by designing all structures to handle the largest earthquake in our lifetimes. It is also important to note that Cascadia elevates the hazard level to "Very Strong" near Boardman where the transmission line begins its journey Southward.

Upon investigation, sandy soils under strong seismic forces can liquefy and render their foundations unstable, additionally it should be noted that the B2H line crosses multiple active faults within Oregon. Active faults are shown in the map above. Faults are seen south of Pilot Rock, near LaGrande and near Baker City. It is concerning that IPC has made the decision not to raise their risk category from Category II to Category III in the structural design to resist"extreme events ." However, the data suggests no consideration has been applied to this event.
