**BEFORE THE PUBLIC UTILITY COMMISSION
OF OREGON**

IN THE MATTER OF IDAHO POWER COMPANY'S, PETITION FOR CERTIFICATE OF PUBLIC CONVENIENCE AND NECESSITY.	Docket: PCN 5 Testimony Sam Myers
--	--

Sam Myers, Intervenor

30 Year Severe Weather Recap

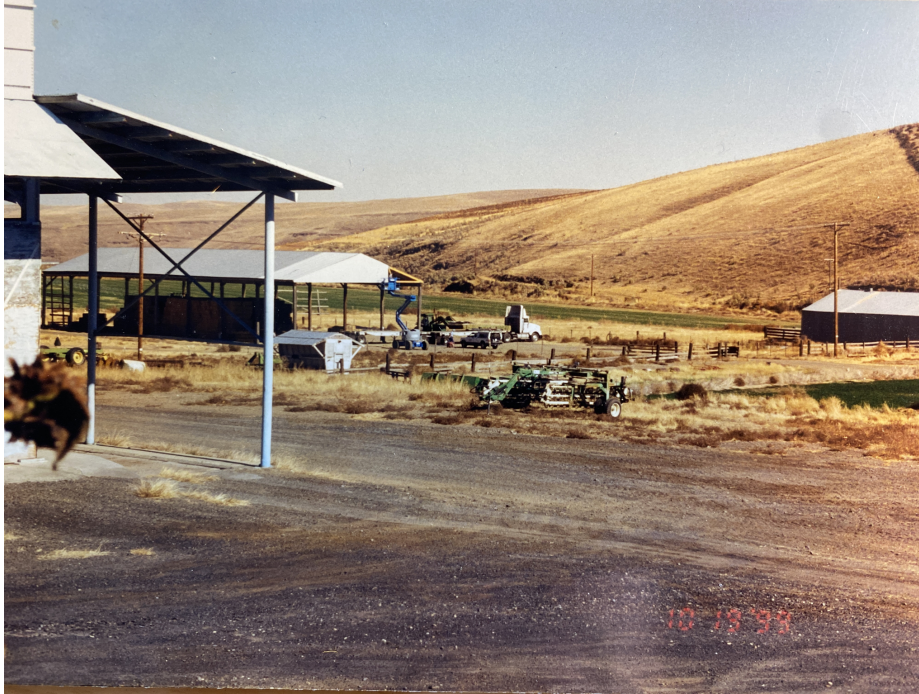
3. [March 2, 1999 - High Wind Event](#). During the spring of 1999 we had a wind event that blew off the roof of a building on our farm(see picture below). The contractor that was repairing this building commented that the winds reached 100mph+ based on the damage he saw.

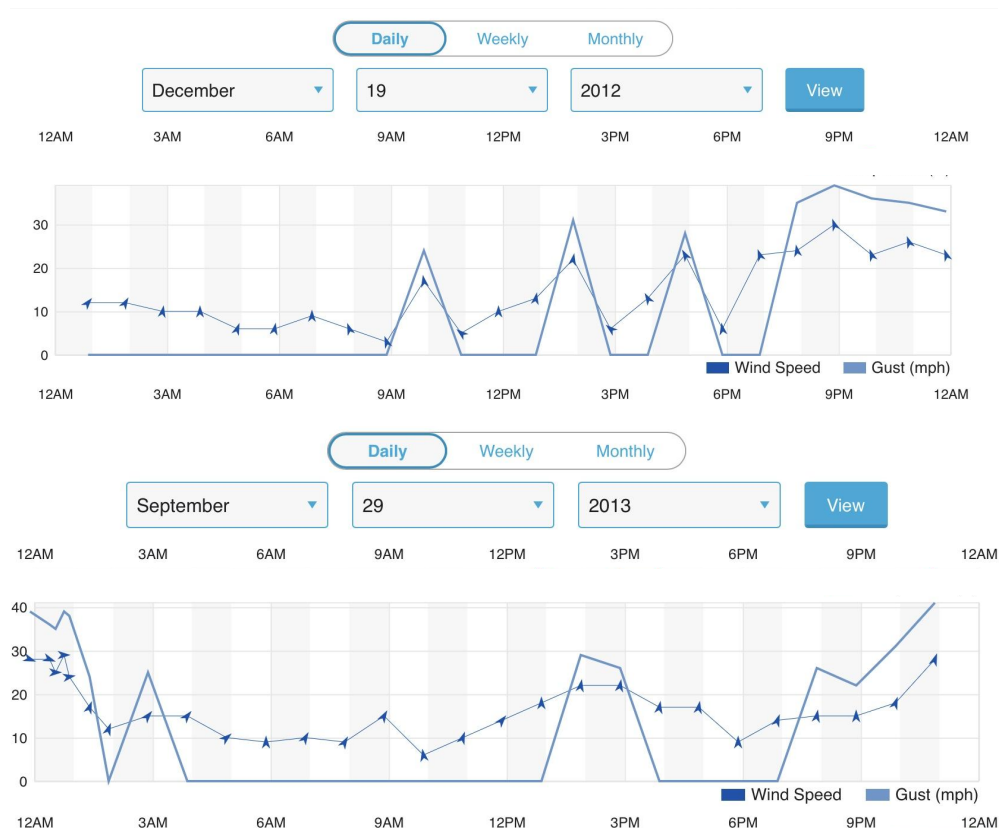
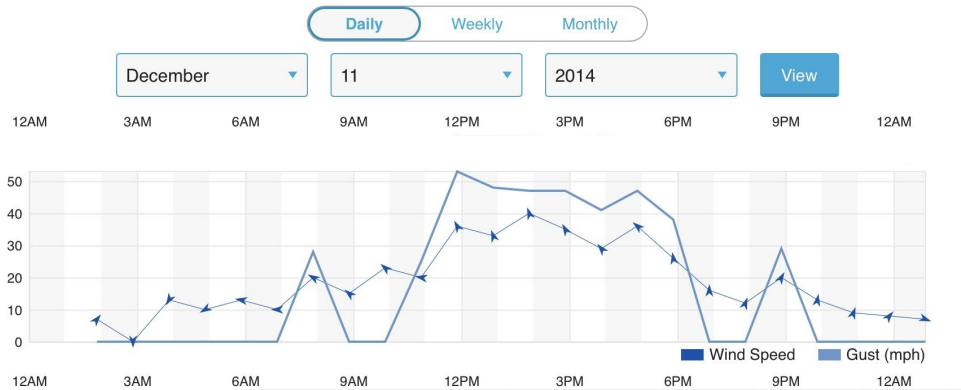
Morrow County Weather Variances

Looking at our recorded wind speed event dates and comparing those dates to winds recorded to Pendleton, Oregon's weather station(30 miles ENE from our location) you can see a stark difference between the two locations. For our most intense wind events you can see they don't experience the same intensity of wind speeds as experienced on our farm. On these occasions we are experiencing mostly double the wind speeds as the recorded speeds observed at the weather station. This confirms our first hand experience in dramatic fashion. IPC has not recognized this climatic phenomenon. The continued neglect of this data can produce deadly consequences to those in our community. Tower failure and catastrophic fires must be avoided at all costs. Collected from: <https://www.wunderground.com/weather/us/or/pendleton>
