**BEFORE THE PUBLIC UTILITY COMMISSION
OF OREGON**

| IN THE MATTER OF IDAHO POWER COMPANY'S, PETITION FOR CERTIFICATE OF PUBLIC CONVENIENCE AND NECESSITY. | Docket: PCN 5 Testimony Sam Myers |

30 Year Severe Weather Recap

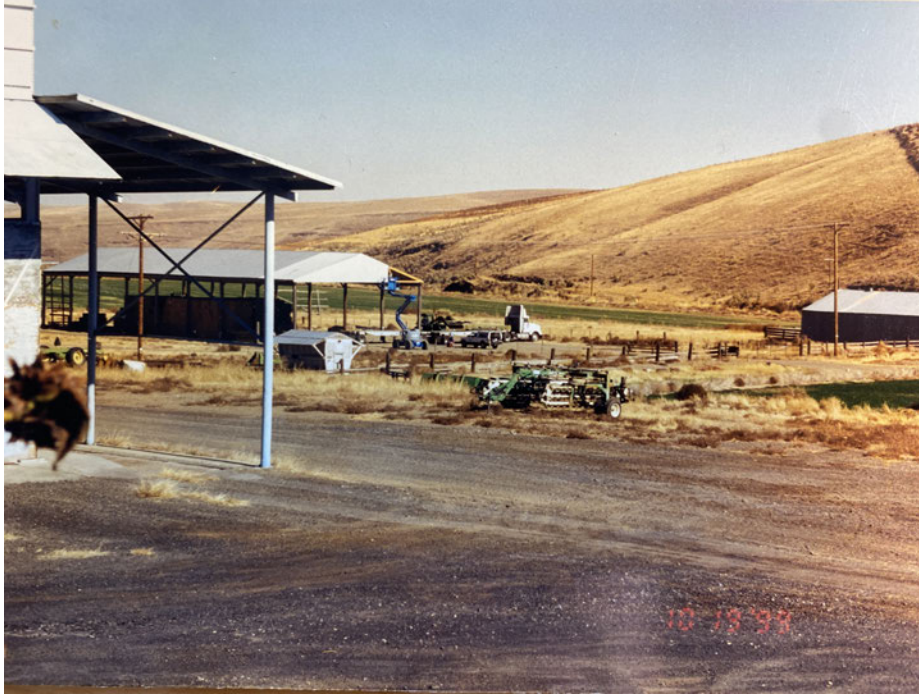
3. [March 2, 1999 - High Wind Event](#). During the spring of 1999 we had a wind event that blew off the roof of a building on our farm(see picture below). The contractor that was repairing this building commented that the winds reached 100mph+ based on the damage he saw.

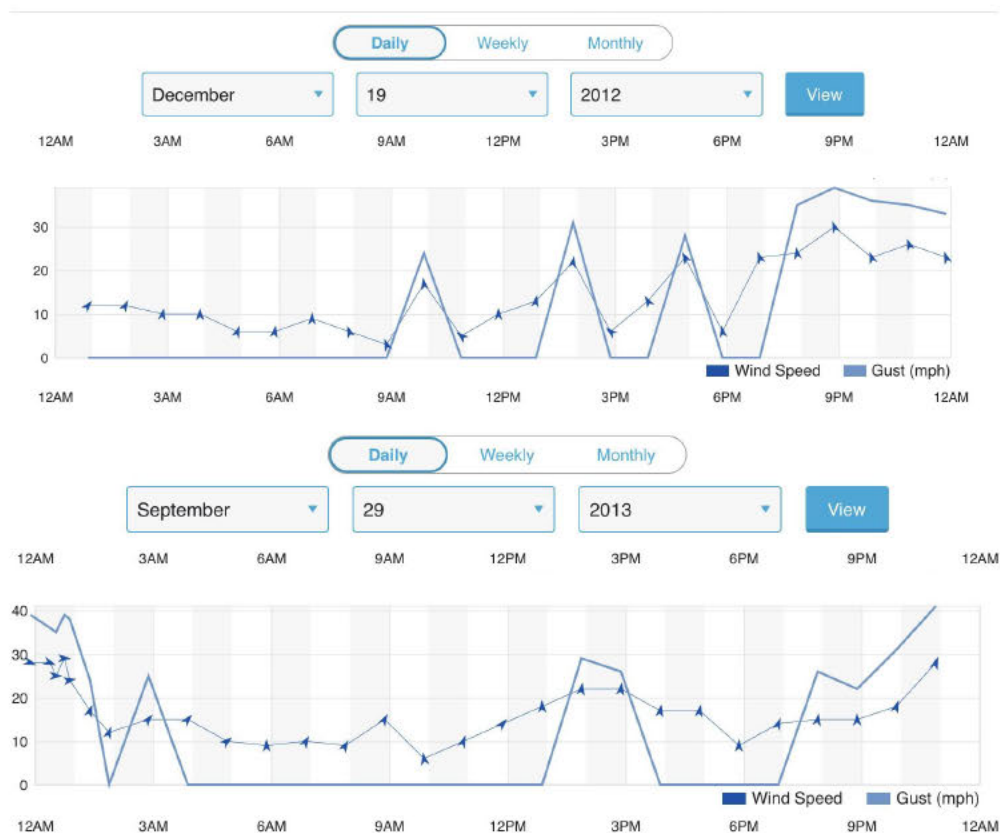
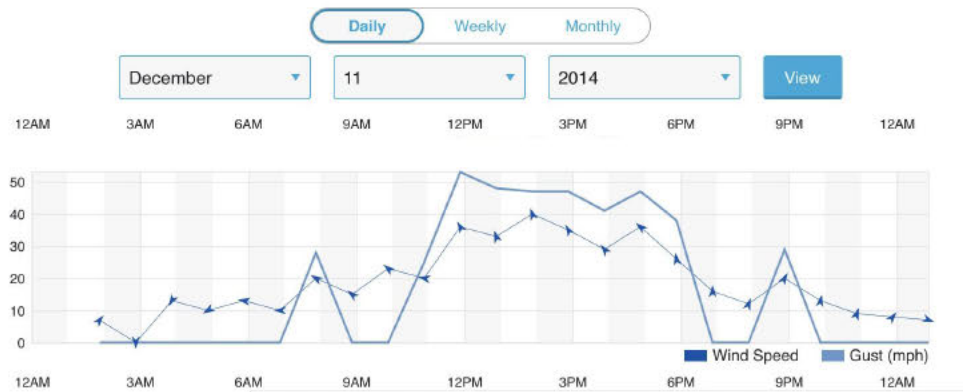
Looking at our recorded wind speed event dates and comparing those dates to winds recorded to Pendleton, Oregon's weather station(30 miles ENE from our location) you can see a stark difference between the two locations. For our most intense wind events you can see they don't experience the same intensity of wind speeds as experienced on our farm. On these occasions we are experiencing mostly double the wind speeds as the recorded speeds observed at the weather station. This confirms our first hand experience in dramatic fashion. IPC has not recognized this climatic phenomenon. The continued neglect of this data can produce deadly consequences to those in our community. Tower failure and catastrophic fires must be avoided at all costs. Collected from: <https://www.wunderground.com/weather/us/or/pendleton>
